AIR INFLATED SYSTEM FOR AN EMERGENCY ROOF

A Case History

KENNETH L. GOLDSBERRY

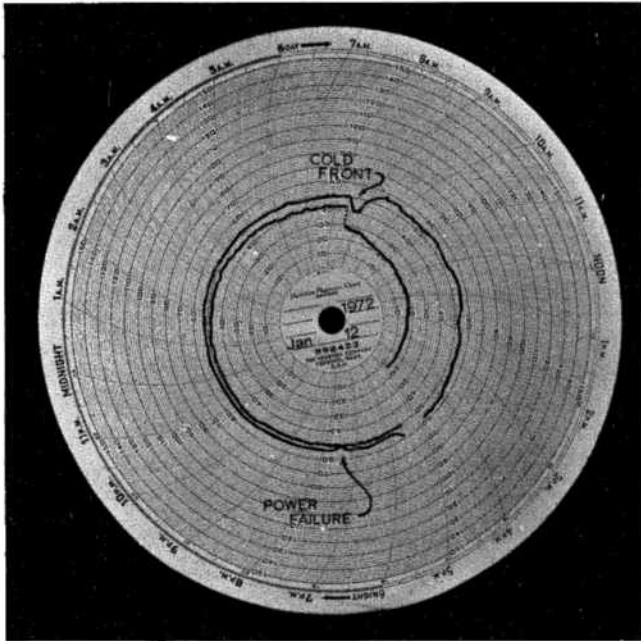
Figure 1

The temperature dropped 12° F in three minutes (See Fig. 1) and was below 20° F by noon. With the help of some very cold fingers, the double plastic layers were secured by 11:30 and the emergency roof inflated. Due to the cold, the plastic could not be stretched tight and on the warmer days to follow took on the appearance of a rather large balloon (Fig. 2).

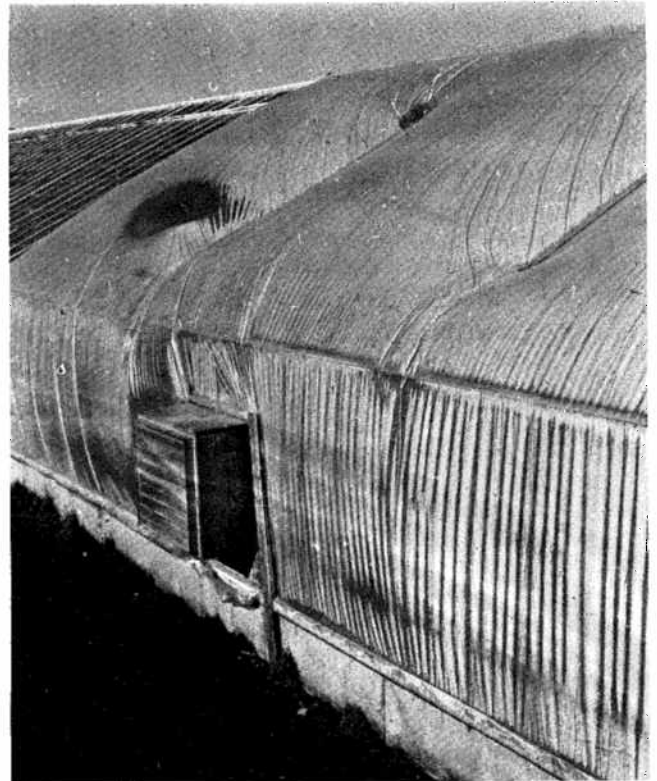
Figure 2

The emergency cover was inflated to a pressure of approximately 0.2 inches of water pressure. Winds continued to blow during the winter and the new covering withstood

gusts up to 80 miles per hour. The cover remained on the house and was still in good condition in June when it was replaced with FRP panels. The 100' x 40', 6 mil polyethylene film had done its job in saving a \$6,000 rose research project.
