Bulletin 297

March 1975

## Refinishing FRP Greenhouse Panels

KENNETH L. GOLDSBERRY<sup>1</sup> and TOM HOMAN<sup>2</sup>

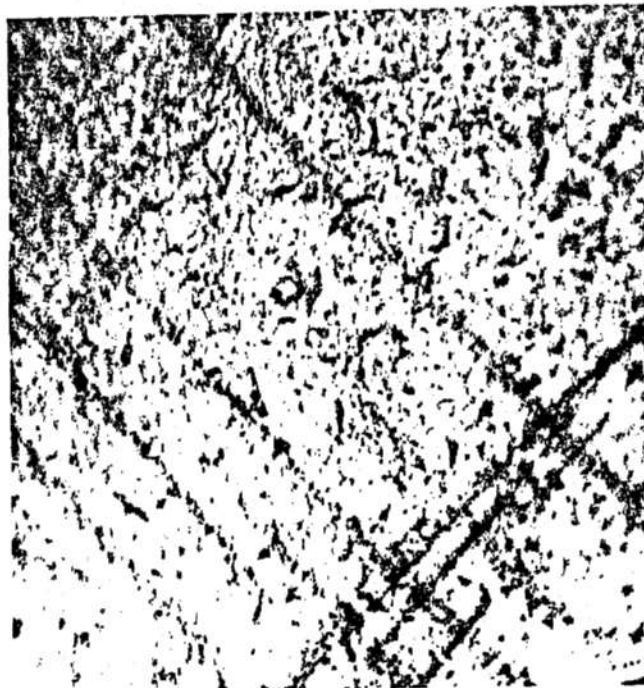
In 1971 a series of 3-10-year-old greenhouse panels was evaluated for physical characteristics of the surface as related to the need to be refinished (2). Some panels fewer than three years old had fiber "bloom," and a few new panels had imperfections that contributed to early weathering (Fig. 1, 2). All of the weathered panels had developed a surface characteristic called "polygonal" cracking (3). It was concluded that the inability of refinishers to adhere to weathered FRP panels is due to the different degrees of elasticity of the panel surface and that of the refinishing material. The panel surface continues to "crack" and the refinisher cracks and flakes off like dandruff.

Figure 1. Irregular cracking observed in new non surface treated panel (2).

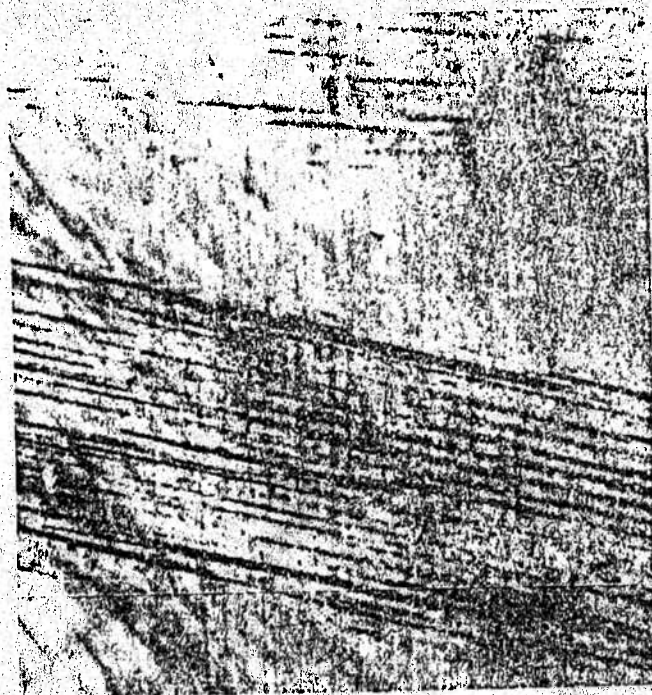
Figure 2. Exposed glass fibers in factory run non surface treated FRP panel (2).

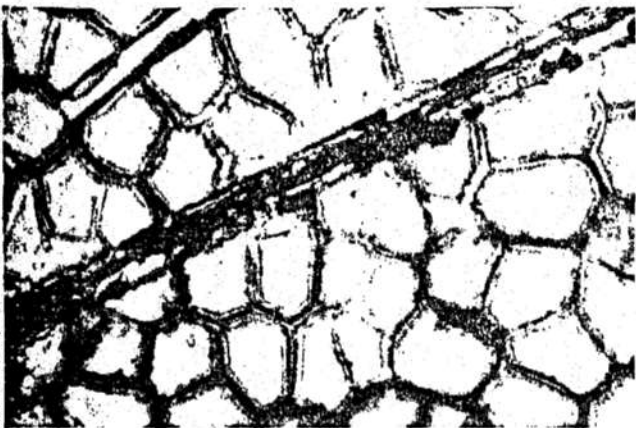
Figure 3. Polygonal cracking found in some weathered greenhouse FRP panels (2).

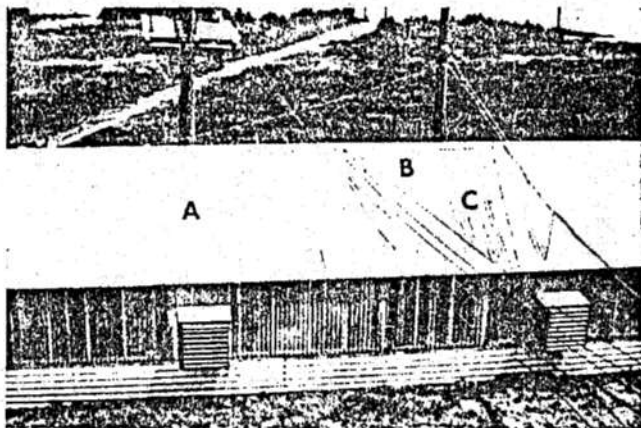
Refinisher treatments 1 and 2 were silicone resins. Both materials began peeling in approximately 12 months after application. When the panels were removed July 7, 1974, approximately 1/8 of the coatings had peeled off the individual panels and the remaining refinisher had turned almost milk white (Fig. 4).

but did not turn milky white; however, it did start "flaking off" approximately 14 months after application. It is assumed that a hard rain or even a hail storm could have removed most of the remaining coating at the time of panel removal. The refinisher on the panel was beginning to develop a yellow hue.

Figure 4. Greenhouse, with panels pretreated and coated with refinishers, 21 months after application. (A) Coating that turned white but still transparent. (B) an untreated panel and blooming. (C) continental coating starting to flake.

Until there is evidence to the contrary, it is recommended that FRP panels not be refinished because it has not been proven economical. It costs more than 10¢ per sq. ft. to have a roof refinished, and it is only beneficial for the first 6-12 months after application.
