Some Precautions During Greenhouse Rehabilitation

John G. Seeley, Cornell University, Ithaca, New York

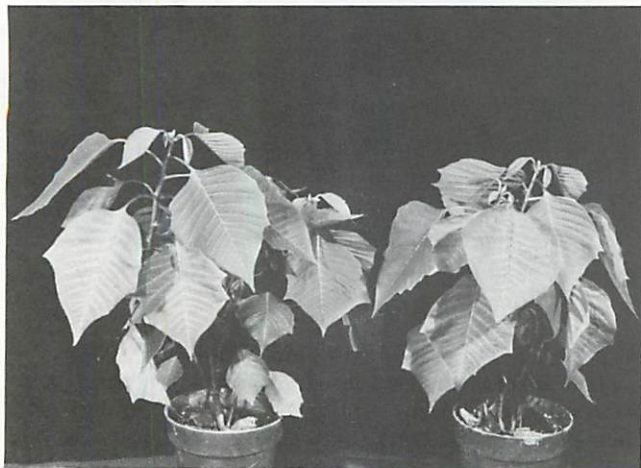
In the summer of 1978, the headhouse was being given an application of black roofing compound. The material was heated in a large vat, and raised to the roof where it was applied. Unfortunately, the wind was blowing and air currents eddied down to a greenhouse where exhaust fans were operating to remove excess summer heat. But apparently fumes from the roofing job were drawn into the greenhouse which fortunately was relatively empty.

Poinsettia plants exposed to the fumes developed chlorosis along the veins (Figure 1) and growth was inhibited. There was considerable leaf drop but the plants recovered. However, New Guinea Hybrid Impatiens plants in the same location were severely injured (Figure 2) and many plants died.

Figure 1. Chlorosis of poinsettia caused by fumes from roofing project.

This was a rather unusual situation, but the lesson to be learned is that it can happen, so take care to avoid the problem.

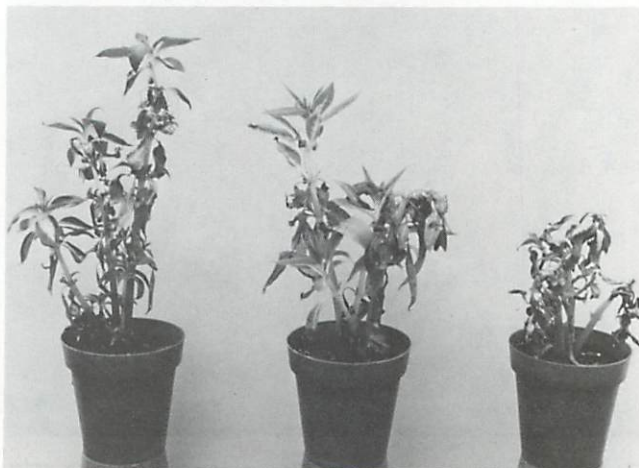
Figure 2. Injury to New Guinea Hybrid Impatiens by fumes from roofing job.

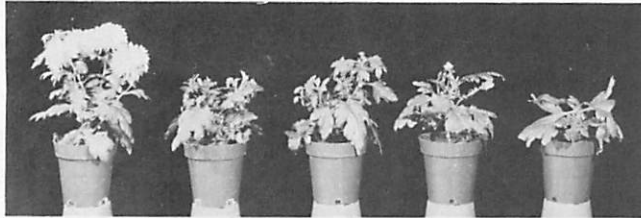
You probably recall the article in the NYSFI Bulletin 72 (July, 1976) giving information about 2 instances of plant injury by paint volatiles. One was injury to potted

chrysanthemums (Figure 3) and the other was a severe monetary loss in cut flower roses (Figure 4). In both situations, the paints were aluminum paints which contained xylene and were not standard greenhouse paints.

Figure 3. Left: a normal branched chrysanthemum plant. Right: 4 plants exposed to paint fumes, given a pinch to induce branching, and photographed a few weeks later. Leaves were distorted, and axillary buds aborted.

1. Use high grade greenhouse paint from a reliable source having had experience with satisfactory greenhouse paints. Don't just "run down" to the local store and pick up "whatever happens to be available."
2. Paint only when good ventilation is available. Ventilating prevents build-up of a toxic concentration of vapors. That is why summer is a good time to do your painting.

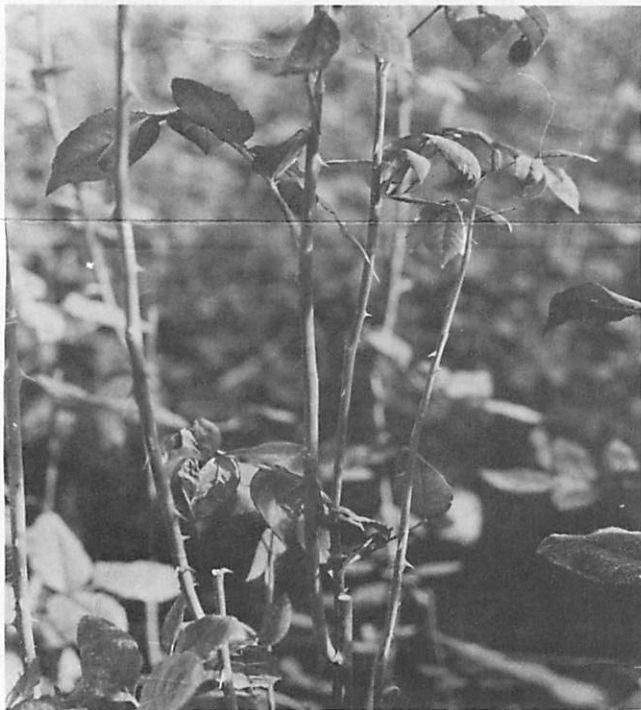
Figure 4. Leaf injury and leaf drop of roses due to volatiles released when heating pipes were painted with a specific kind of aluminum paint.

3. When possible, paint moveable objects out of doors or at least not where the vapors may affect plants.
4. Don't paint heating pipes with metallic paint. Metallic paints reduce heat transfer by about 25 percent. That is the opposite of energy conservation.
5. Ventilate. If paint has been applied, keep the vents open, or the exhaust fans operating, to exhaust the paint volatiles, and keep the concentration below any possible injury level.

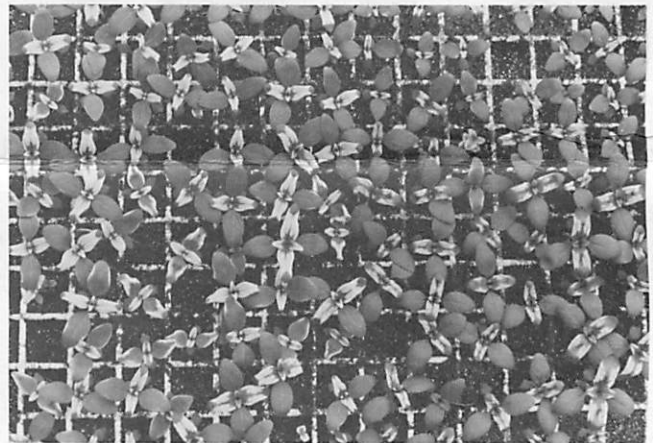
During the past year, two additional problems were brought to my attention. In a growth room (a basement room with fluorescent lights) for growing seedlings, a pressure can of spray paint was used to "touch up" some parts of the benches. Subsequently, snapdragon seedlings developed chlorotic leaves (Figure 5). Although the plants were not killed, growth was set back. The injury was probably caused by the propellant in the aerosol pressure can. In some earlier tests, it was found that the propellant for one type of pressure spray paint container caused axillary bud abortion and leaf injury of chrysanthemums, similar to that in Figure 3. The growth room had minimal ventilation so the paint fumes were concentrated more than would happen in a well-ventilated location. It was interesting that some snapdragon cultivars were injured more than others, similar to the differences in susceptibility observed with chrysanthemum.

Figure 5. Snapdragon seedlings exposed to fumes from a pressure can of spray paint.

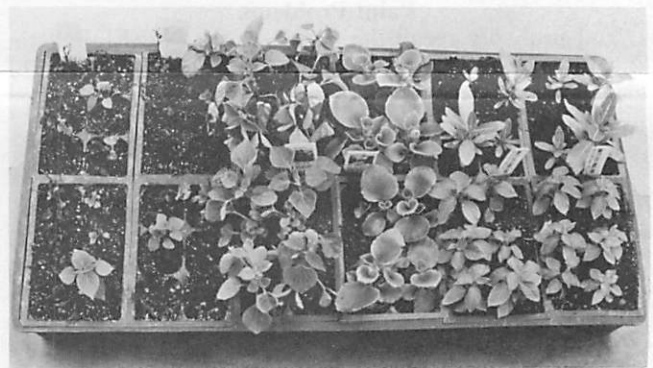
In early May this year, another possible paint problem was brought to my attention. The tray of annuals (Figure 6) came from a greenhouse in which the steam pipes were painted with an aluminum paint. (At this time I don't know which brand or type.) In an adjacent greenhouse, where painting had not been done, there was no plant injury. So it is suspected that the "culprit" was the paint. More details are being obtained.

In Figure 6, the four packs of *Salvia* on the left were killed or severely injured and did not recover. The next two packs of *Salvia* (a different cultivar) were injured less, recovered and bloomed in mid-June. The photograph was on May 9. *Begonia Viva*, *Browallia Blue Bells*, and *Coquette* (Little Pinkie) *Vinca* all show slight chlorosis but recovered satisfactorily with flowering in early to mid-June. Other cultivars that were injured were *Salvia farinacea*, *Browallia Marine Bells*, *Coleus candidum* and *Fiji Mix*, *Begonia Scarletta*, *Ambra White* and *Pink Tausendschoen*, *Ageratum Summer Snow* and *Blue Blazer*, and *Dusty Miller Silver Dust*.

Figure 6. Bedding plants presumably injured by paint fumes in a greenhouse.
